FOREST HILL PARK

Updated Master Plan 1999

Volume II

East Cleveland and Cleveland Heights, Ohio

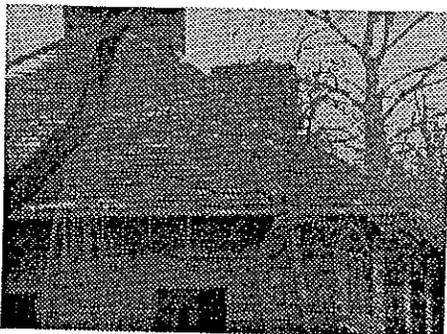
The Boathouse

Roof shingles are missing from the hip ridge.

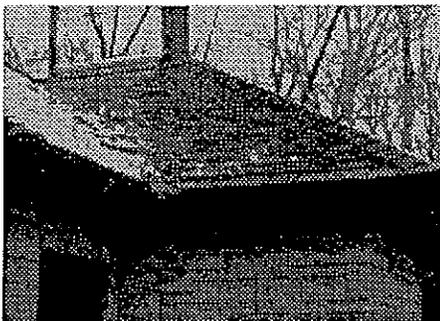
heavy accumulations of moss

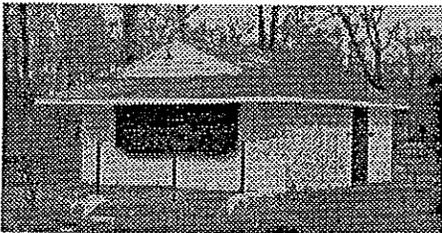
Old Concession Stand

This building is a painted block structure. It has little architectural character. It is currently being used for storage. As part of an overall plan for maintenance this structure should be removed or replaced.

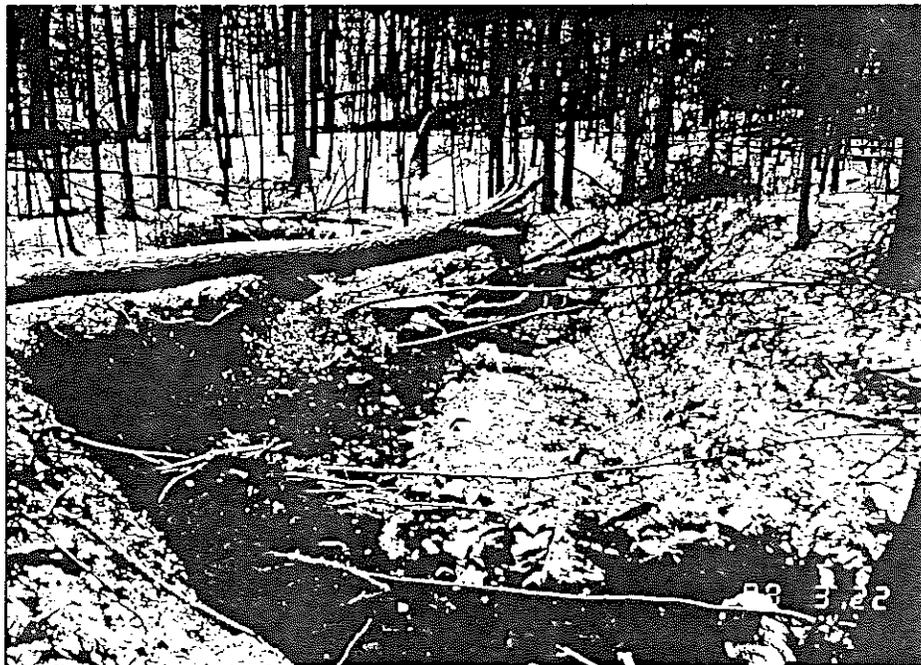
FIG. 27b

EMBANKMENT WASHOUT AND FALLEN TREES

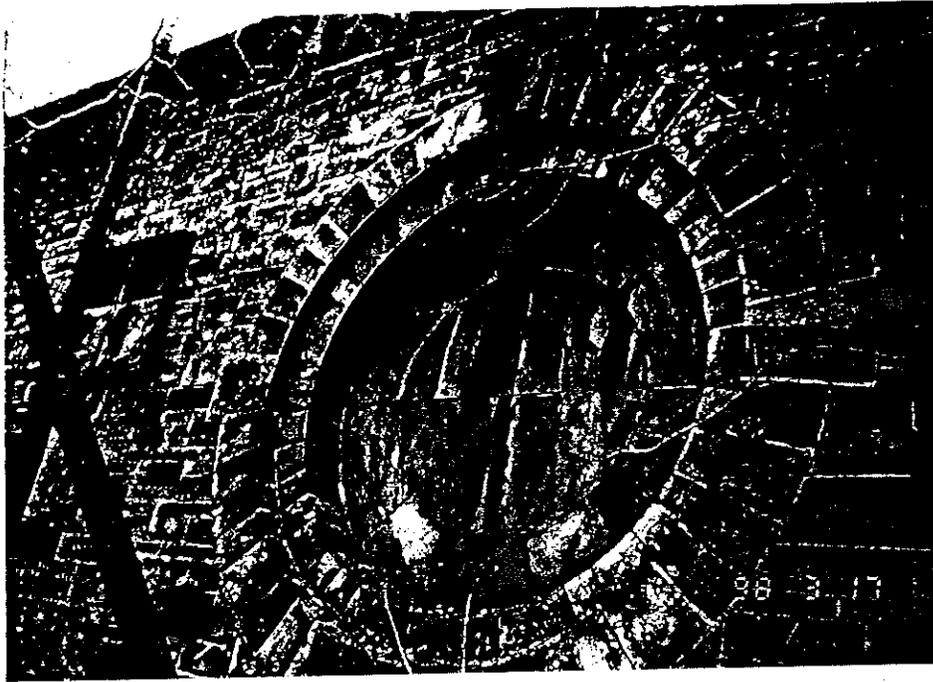
FIG. 37

KEYSTONE STONE MISSING
18" Diameter Circle

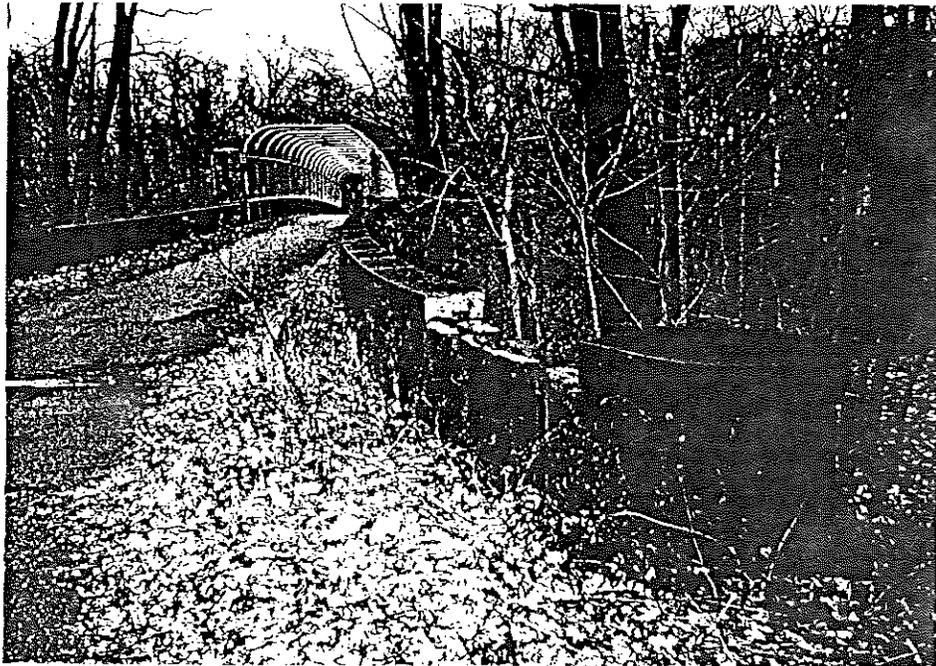
FIG.40

MISSING STONE CAPS
