Ecological Inventory Report

Aquatic and Terrestrial Animal Communities

*Upper Dugway Valley
Forest Hill Park
Cleveland Heights, Ohio*

Prepared by
Davey Resource Group
1500 North Mantua Street
P.O. Box 5193
Kent, Ohio 44240
800-828-8312

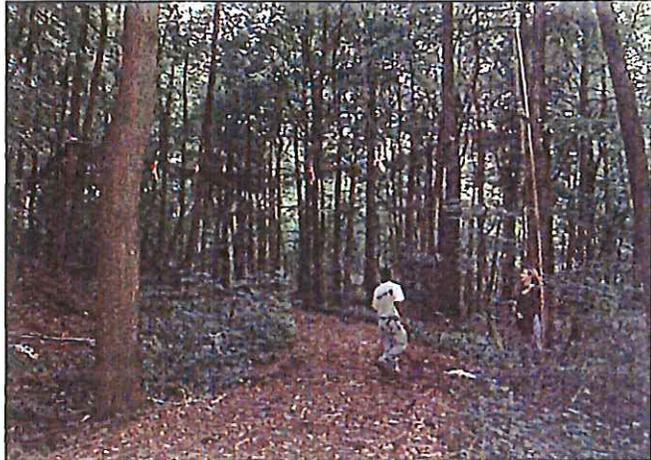
Station 1 (July 30, 2003 and July 31, 2003)

Station 1 was located at a straight portion of the walking trail in successional woods under a closed tree canopy. Three tiers of nets (9 meters long) were stretched across this potential flight corridor and extended to the underside of the tree canopy.

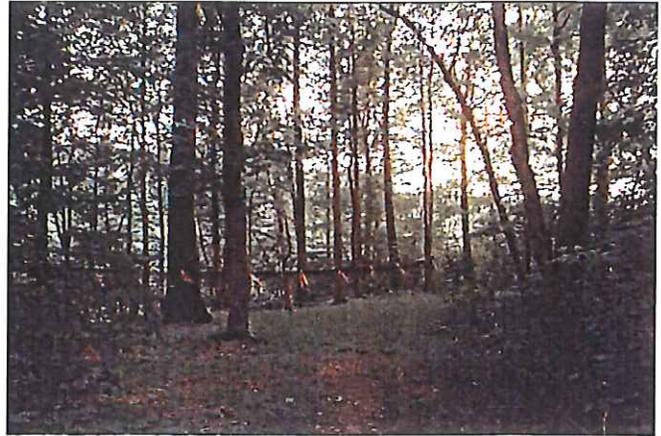
Station 4 (July 31, 2003)

Station 4 was located in a small clearing at the top of two ravines. Two walking trails pass through this area affording two intersecting flight corridors. Three tiers of 18-meter-long nets were stretched diagonally across the clearing to intercept both potential flight corridors. The canopy was not completely closed off, but the angle of the flight corridors were such that bats would have difficulty avoiding the nets.
