FOREST HILL PARK

Updated Master Plan 1999

Volume II

East Cleveland and Cleveland Heights, Ohio

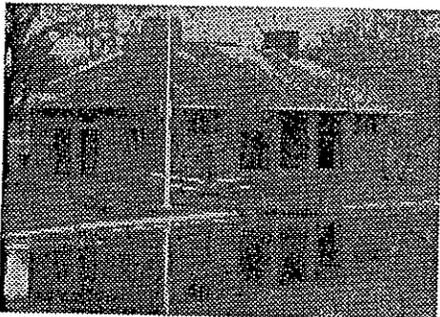
The Boathouse

The roofing material needs further investigation, from the ground it appears to be natural slate, but the original drawings indicate that it may be a manufactured composite material. Often these types of manufactured slates contain asbestos. While it is not recommended that the roofing be removed, it is important to identify the contents of the material. This will insure that workers and the public can be protected when the roofs are repaired

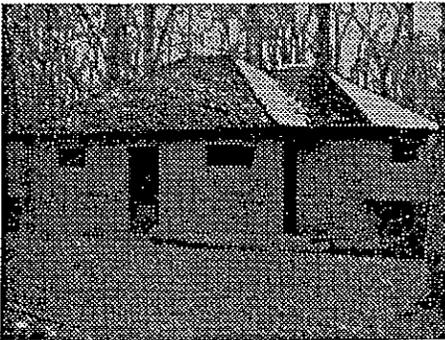
Meadow Area Comfort Station

The building is similar in material to the boathouse, and is in very good condition. The original copper roof vent is still in place, as well as the flashing. The gutters and downspouts appear to be new, and are good matches to the original drawings.

be vandal resistant. The building has been subject to a minor amount of graffiti. Care should always be taken when cleaning an historic structure, many cleaning agents or anti-graffiti coatings can damage masonry.

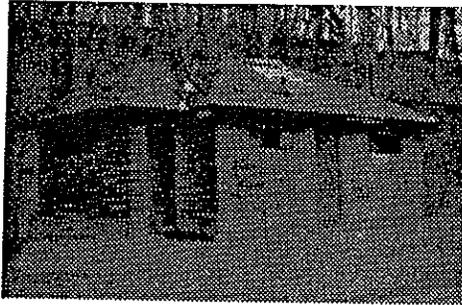
The Dugway Area Comfort Station is labeled Floor Plan "B" on the original drawings. It is of the same materials as the boathouse. It has an entrance on each end of the front elevation for each toilet room, and a center door for a custodial and storage space. There is access to piping in this space as well. This building's roof and copper ventilator have been badly damaged. These appear to have been caused by a tree or large branch falling on the structure. The building was designed to function without gutters and downspouts. It still has its original steel doors and window shutters. They are in fair condition. The building has been subject to a great deal of graffiti. Care should always be taken when cleaning an historic structure, many cleaning agents or anti-graffiti coatings can damage masonry.

This structure is not in use because of problems with piping and maintenance of the plumbing. With a small amount of modification, the toilet rooms have sufficient space to make them accessible to persons with disabilities. See attached plan.

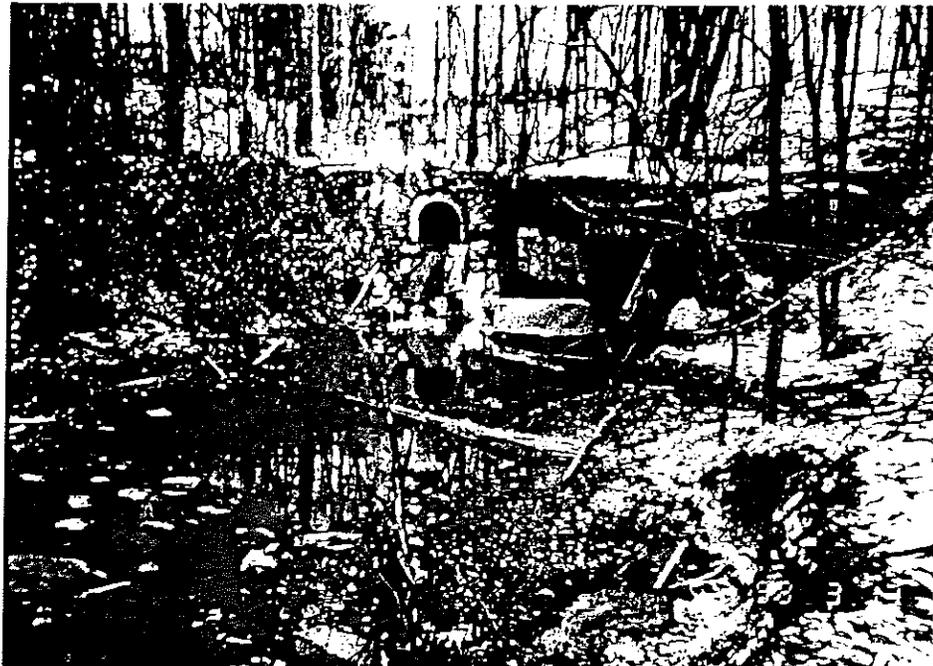
FIG. 9

Secondly, adjacent to the 72" culvert is a 5' x 5' concrete horseshoe arch culvert that also outlets storm water into the Park. The 5' x 5' culvert outlets storm water from Monticello Boulevard and is characterized by its concrete arch and concrete apron slab. The apron slab cantilevers several feet away from the concrete arch headwall and, as a result of erosion, has cracked and nearly fallen into the stream bed. (See FIG.-9)

The combined outlet flow from these two (2) structures (Culvert Structures-C) has caused considerable erosion and resulted in substantial undermining of the larger 72" concrete culvert outlet structure. The embankments have washed away causing sediment sand bars to develop and trees to fall into the stream channel. (See FIG.-10) Sediment sand bars re-direct the water flow up against the embankment thus starting the cycle of embankment washout and tree uprooting.

CULVERT STRUCTURES-C

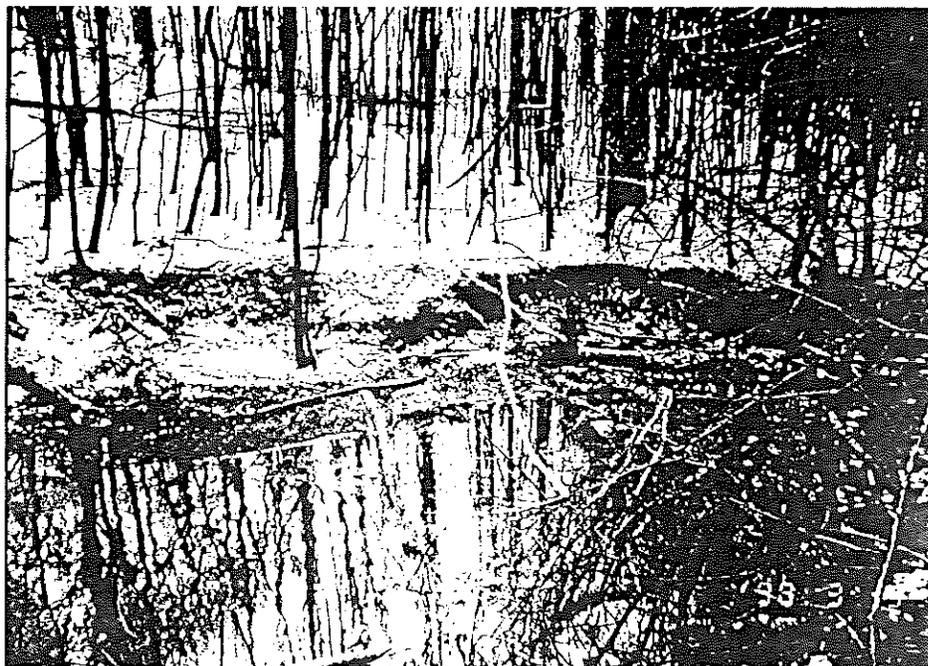
FIG. 10

EMBANKMENT WASHOUT

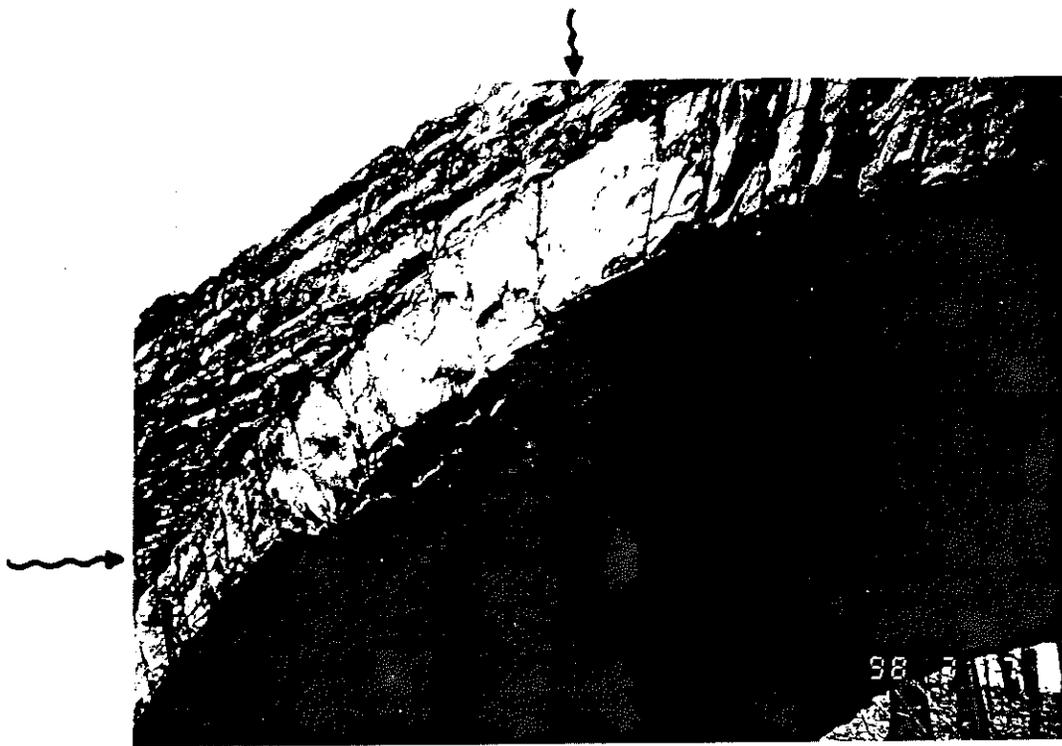
FIG.32

The bridge arch span is held together with steel bars just above the arch opening. Their structural integrity and amount of section loss cannot be determined without invasive inspection. (See FIG.-32) The area of immediate attention shall include cleaning concrete drainage troughs along the inside of the stone parapets, along with filling and sealing cracks and joints on the deck to prevent water from further accelerating deterioration. (See FIG.-33) Close attention shall be directed to loose stones falling out from the bridge. Any further rehabilitation by grout injection could be investigated although this structure is probably reaching a point beyond cost effective repair, and an assessment of its functional use should be undertaken to determine its future within the Park landscape.

STEEL TENDON BARS

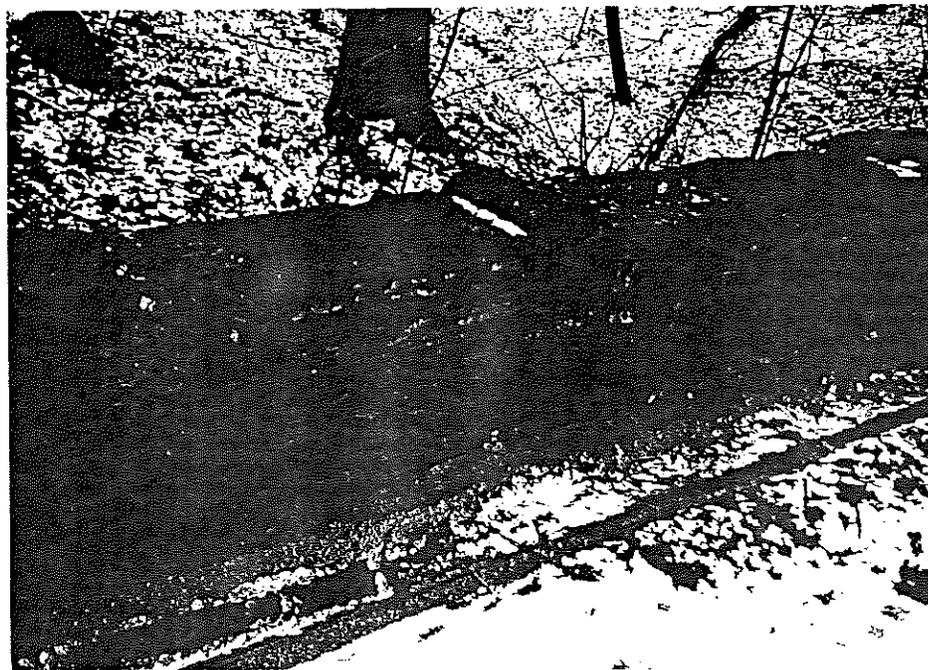
FIG. 33

CONCRETE TROUGH AND
STONE PARAPET

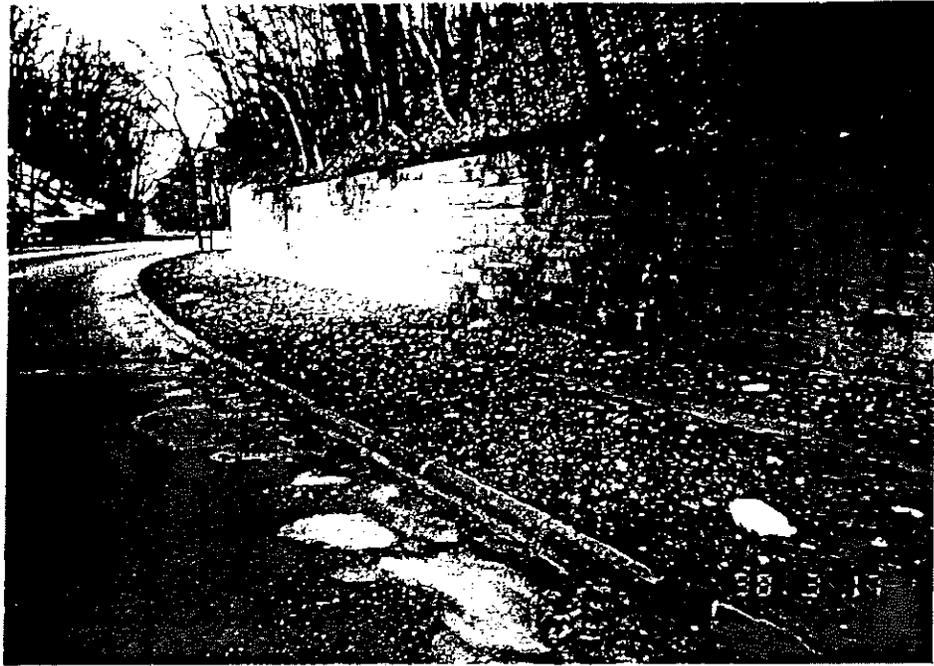
FIG.42

Along Forest Hills Boulevard three (3) sections of stone masonry faced concrete stepped retaining walls stand in the vicinity of the overhead foot bridge which spans Forest Hills Boulevard. These retaining walls hold back earth embankment at the footbridge abutments and at points of steep embankment slopes. Generally the retaining walls appear to be in good condition with minimal repair needed. The retaining walls range from approximately 6' to 12' in height and 120' to 160' in length. (See FIG.-42 & FIG.43)

STONE MASONRY RETAINING WALLS

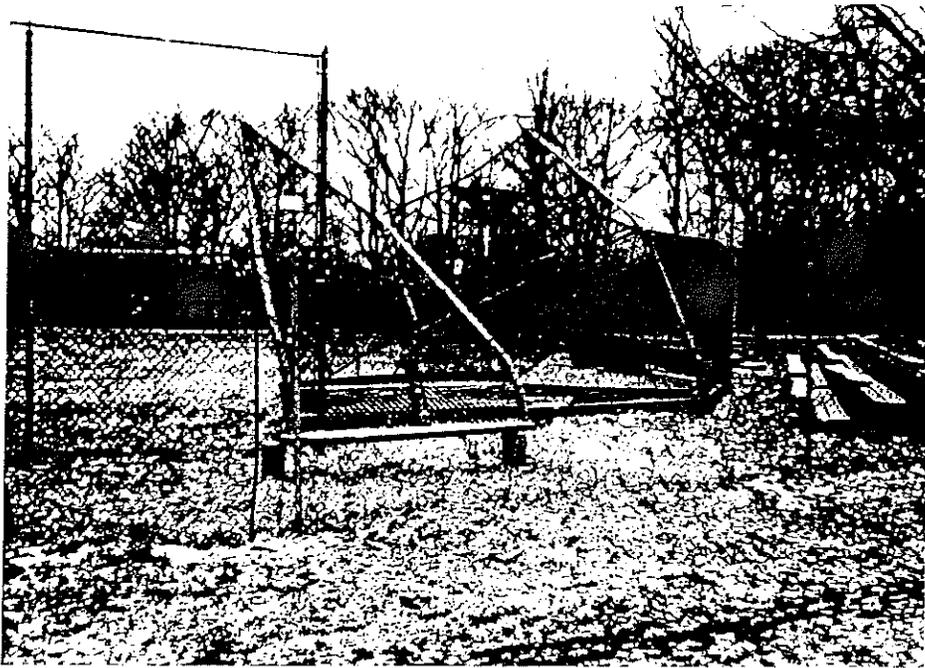
FIG. 47

Another example of damaged fencing is found at the baseball field located at Superior and Eddington Roads. The baseball field is bounded by chain link fencing on Superior Road. Inside this fencing stands a chain link backstop that has been vandalized into subsequent failure. (See FIG.-47)

VANDALIZED BASEBALL BACKSTOP

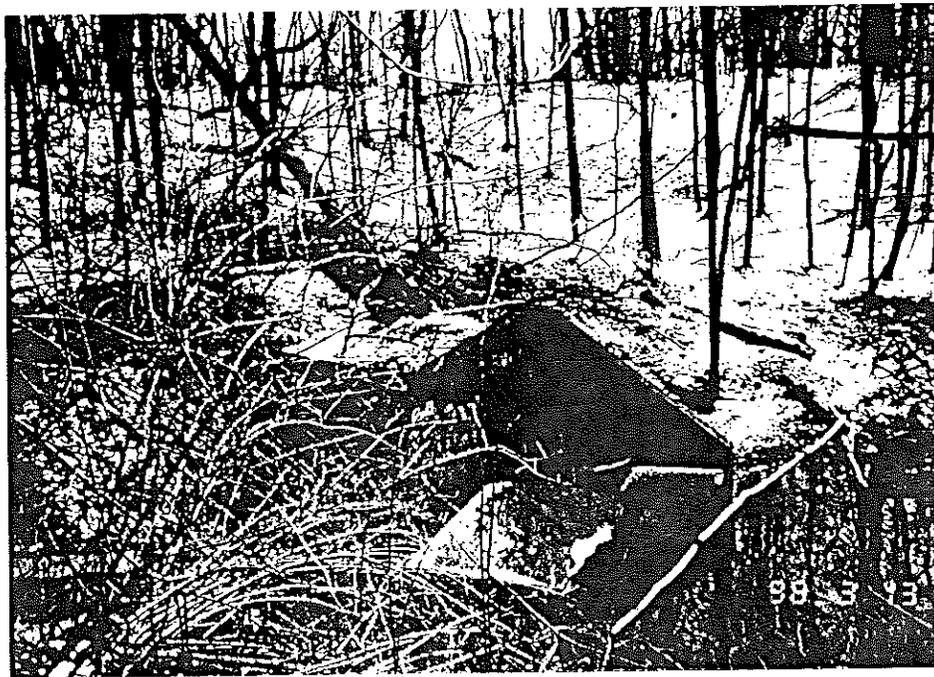
FIG. 6

In the City of Cleveland Heights storm water enters the Park via several large storm water conduits. A 72" reinforced concrete box culvert transfers storm water into the Park near the intersection of Lee Road and Monticello Boulevard. The storm water outlets the culvert through a concrete box headwall with single wingwall.(See FIG.-6) This structure has undergone severe structural distress due to erosion and undermining which has caused this outlet structure to fail. The outlet apron slab has cracked and fallen into the stream bed. Major erosion has caused the culvert joints to become dislodged causing the structure to shift and settle where multiple cracks have severed the culvert into sections. (See FIG.-7 & 8) Un-restricted water flow through the culvert joints has caused major erosion of the adjacent embankment at the culvert outlet. The structure is severely undermined as a result of the un-restricted flow and the outlet portion of this structure must be replaced.

72" REINFORCED CONCRETE BOX CULVERT

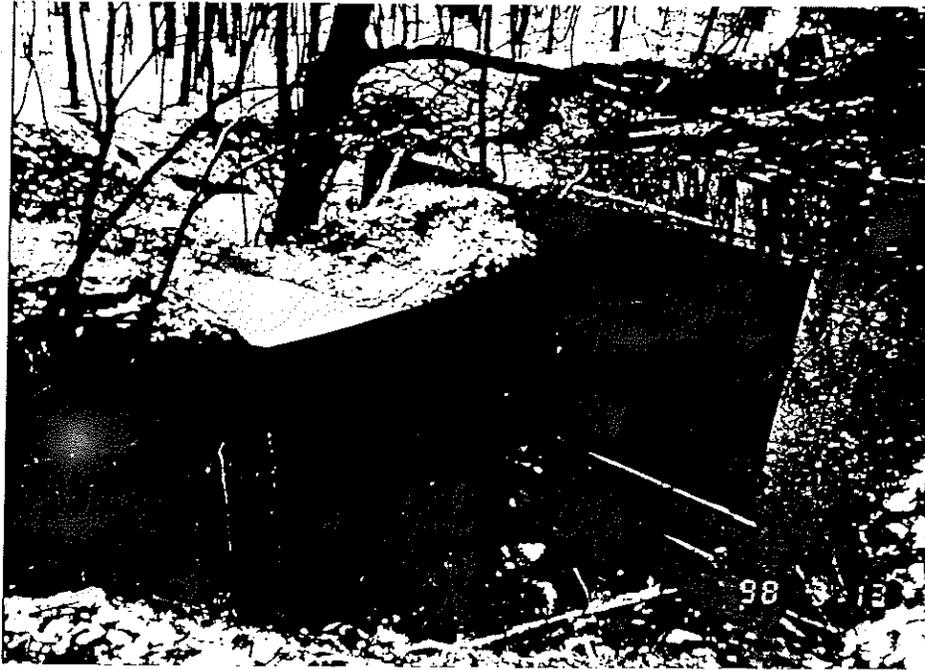
FIG. 7

MAJOR EROSION BEHIND HEADWALL

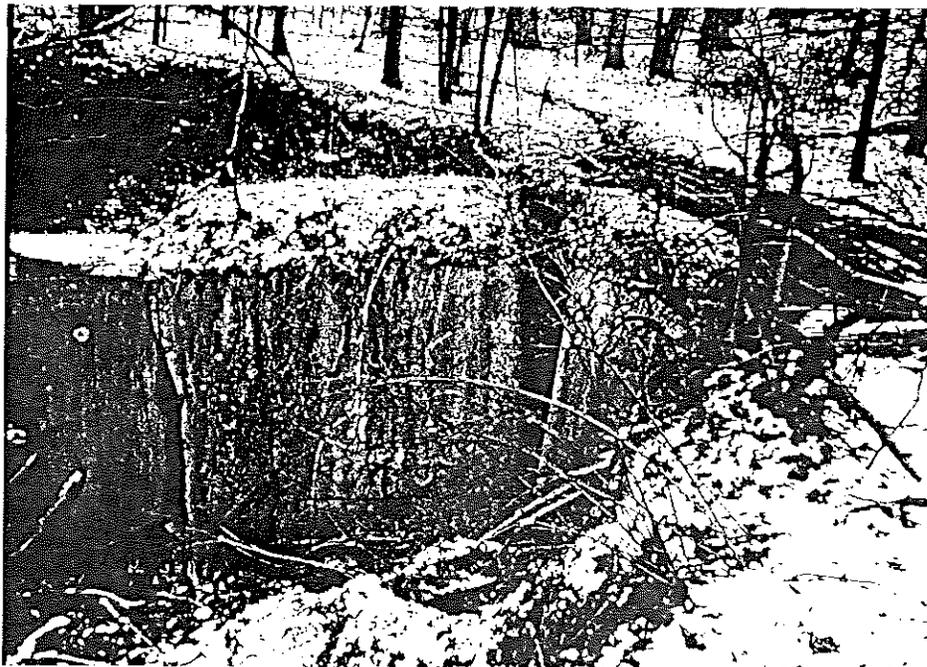
FIG. 8

SEVERED BOX CULVERT

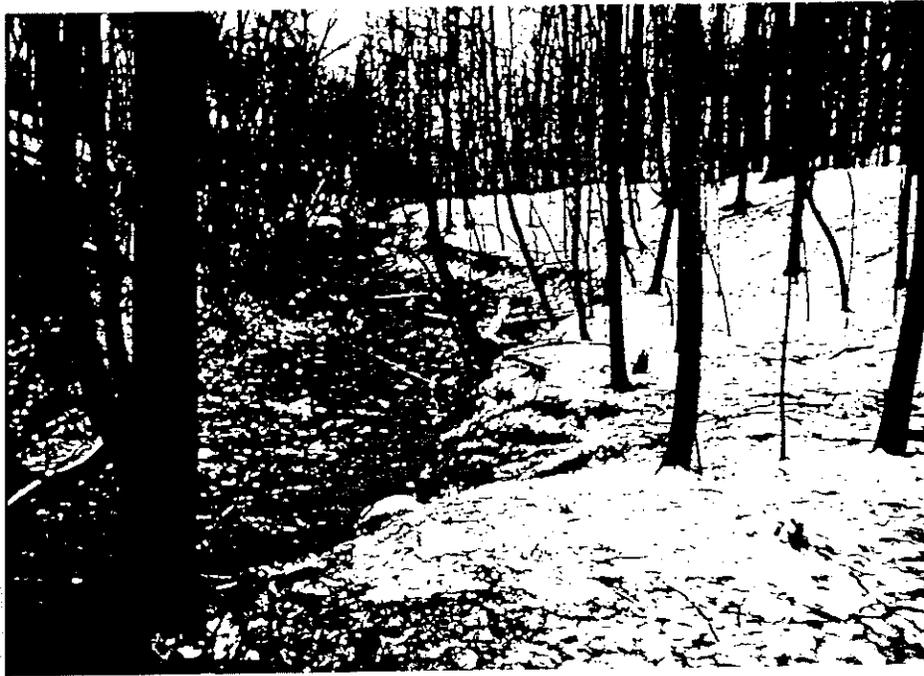
FIG. 11

Storm water from Culvert Structures-C then travels through the channel via a winding water course until combining with the storm water stream outletting from Culvert Structure-D located North west of the Cleveland Heights Pavilion Recreation Building. (See FIG.-11 & 12)

WINDING WATER COURSE

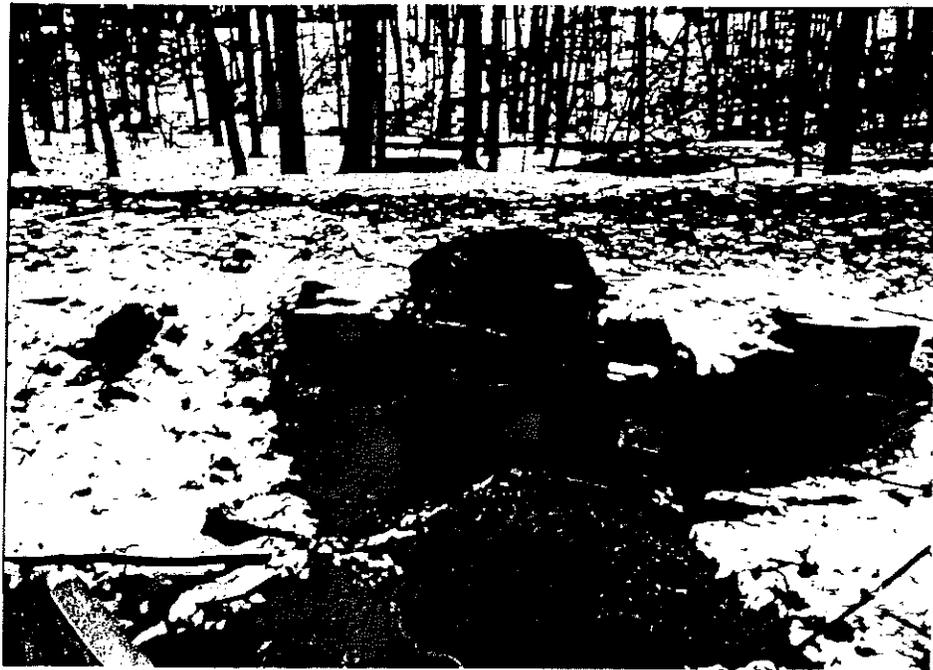
FIG. 24

Landscaped surface water draining into grass swales and the flow from pipe culverts has eroded embankments downstream where unchannelled entrance into the ravine contributes to increasing soil cavities. (See FIG.-23 & 24) Several drainage streams that meander through the Park are controlled via pipe culverts. These pipe culverts are enclosed in stone headwalls or are concrete encased however, flow in many cases is restricted from entering these conduits due to debris clogging the pipe openings. (See FIG.-25 & 26) When the latter occurs surface water finds a path of least resistance around the conduit and headwall causing embankment erosion at stream tributaries. (See FIG.-27)

EROSION FROM GRASS SWALE

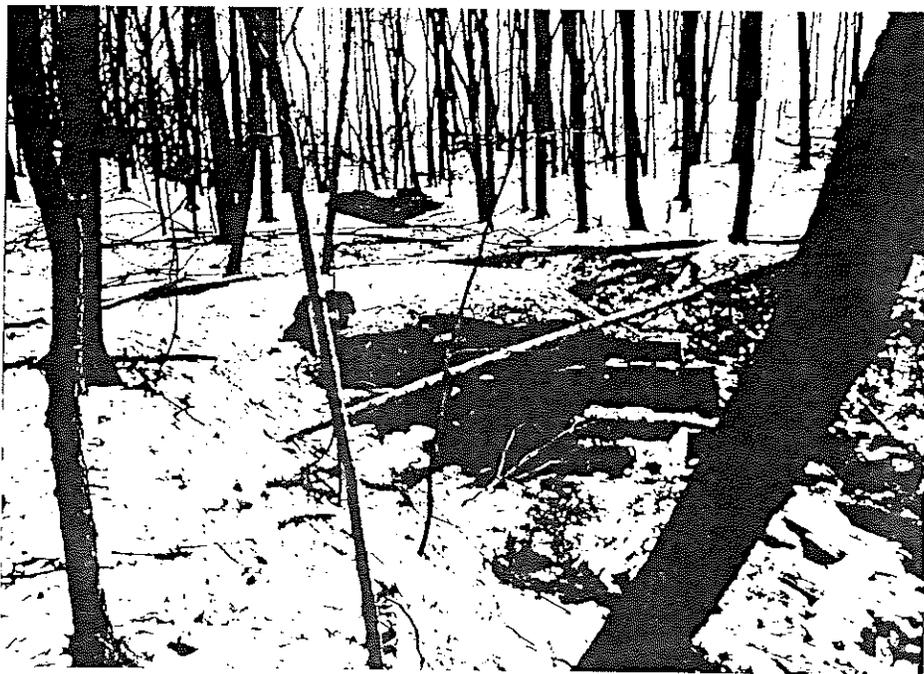
FIG.25

CLOGGED PIPE CULVERT

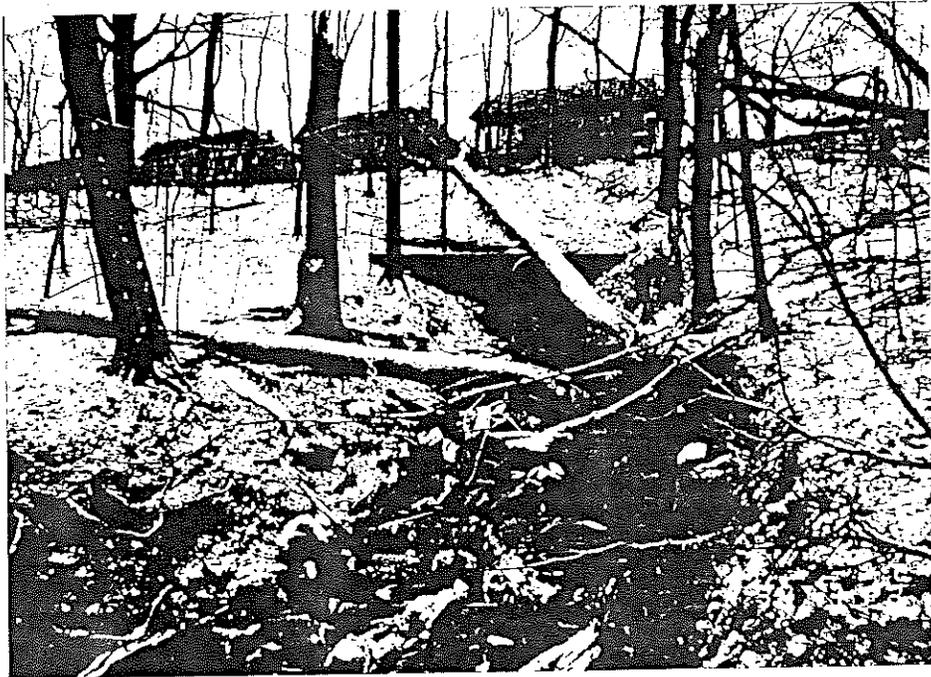
FIG. 27

**PIPE CULVERT
EMBANKMENT EROSION**

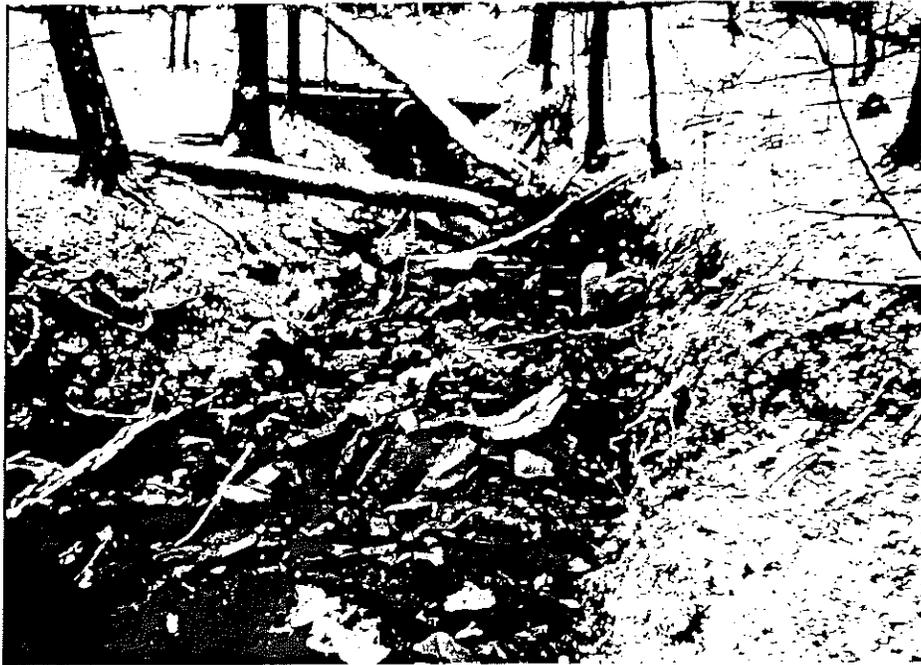
FIG. 27a

Furthermore, drainage pipes that enter the ravine unchannelled at high elevations may cause continuous erosion of the embankment and dislodge rock foundation thus contributing to embankment washout, root failure, and subsequent tree falling. (See FIG. 27a, 27b-27c)

**STORM WATER PIPE SEWER
24" Diameter (I-2)**

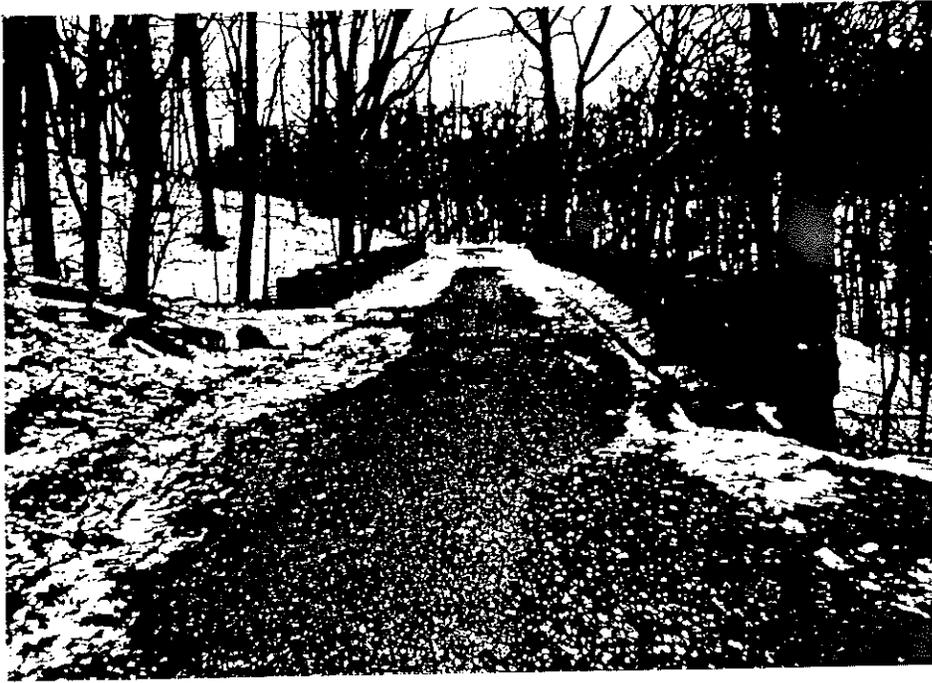
FIG. 27c

EMBANKMENT WASHOUT AND FALLEN TREES

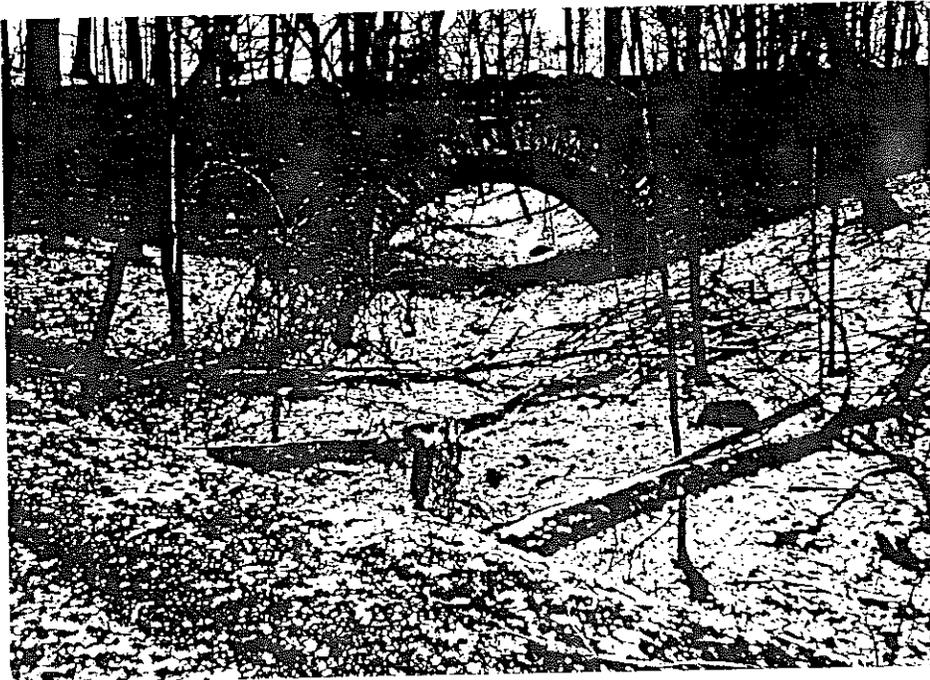
FIG. 28

This stone masonry one span bridge is in an advanced state of deterioration. (See FIG.-28 & 29) The structure is deteriorating primarily due to water draining through stone joints and percolating through the earth fill of the structure. Freeze and thaw cycles are displacing and disintegrating externally exposed sandstone blocks. (See FIG.-30) Previous attempts to pack spalled areas with brick did not contribute to nor preserve the historic and aesthetic value of the structure. (See FIG.-31)

STONE ARCH BRIDGE (Lower Valley)

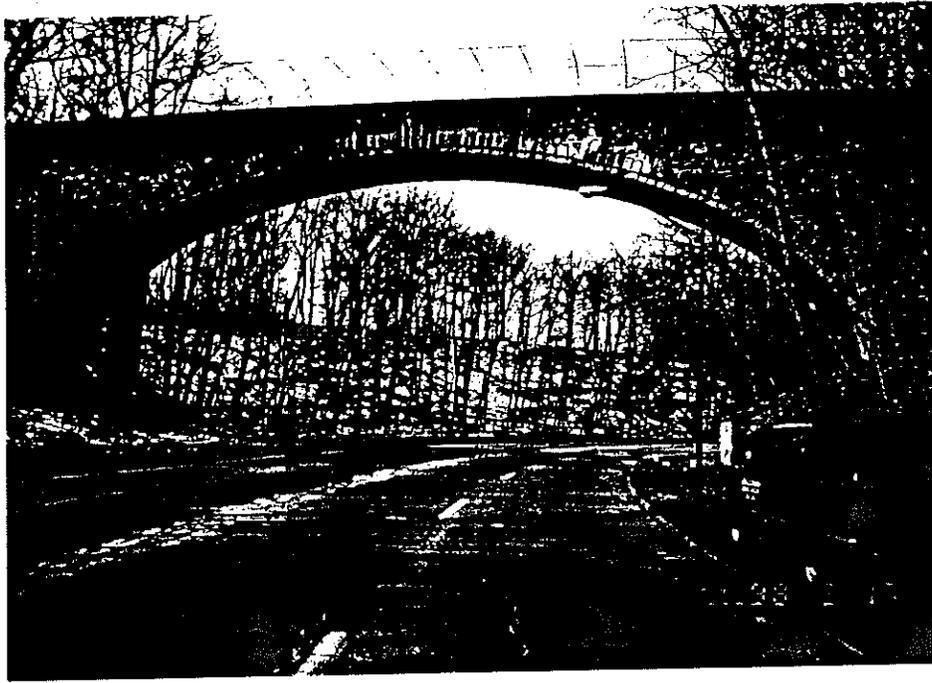
FIG. 31

BRICK PACKING SPALLED AREAS

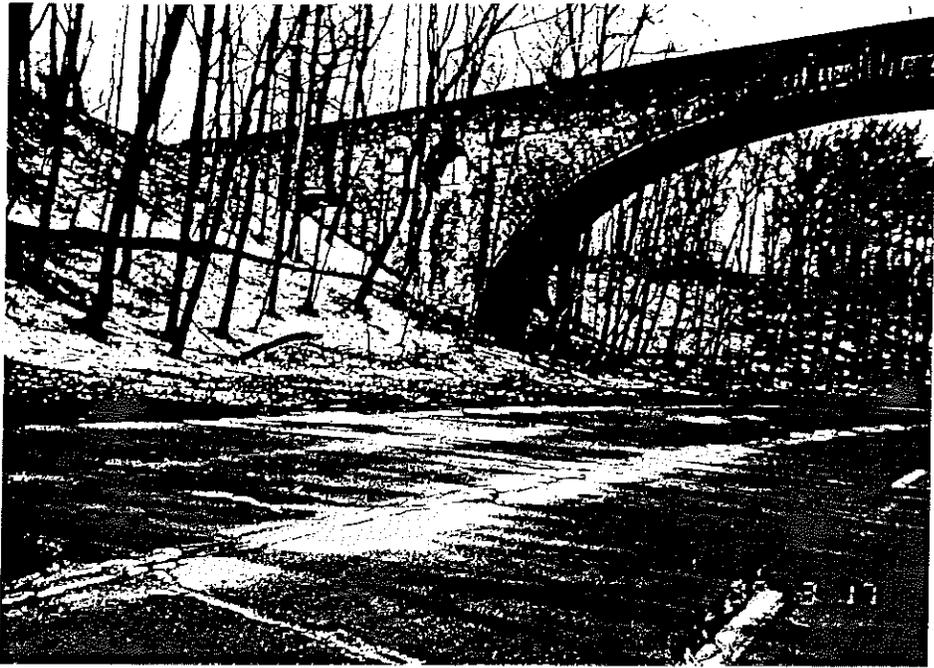
FIG. 35

The 1939 design plans indicate an arched reinforced concrete structure encased with stone masonry veneer panels. The veneer panels were placed on the exposed abutment and superstructure surfaces. The underside of the arch was left with exposed concrete. (See FIG.-35) The bridge deck is asphalt pavement.

STONE MASONRY VENEER PANELS

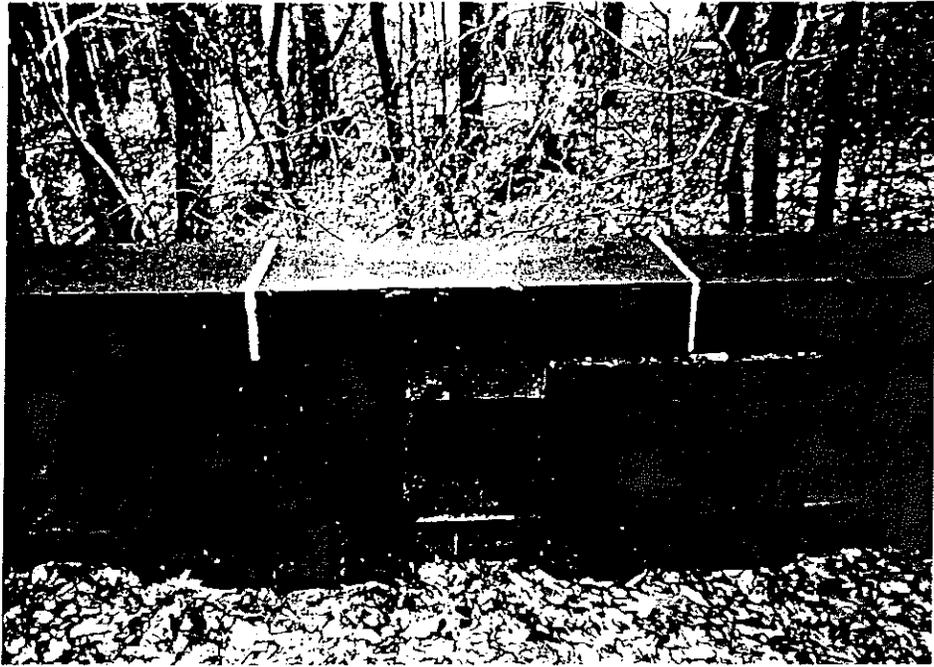
FIG. 39

Finally, some minor spalling has occurred on the three (3) areas of the concrete arch, however not more than 10 square feet of damage is speculated. (See FIG.-39)

VENEER WALL PANEL OPENING

- Installing prefabricated expansion joints
- Replacing key stones
- Repair parapet wall where stone caps are missing (See FIG.-40 & 41)
- Cleaning and sealing gutters
- Remove spalls and patch areas under the arch

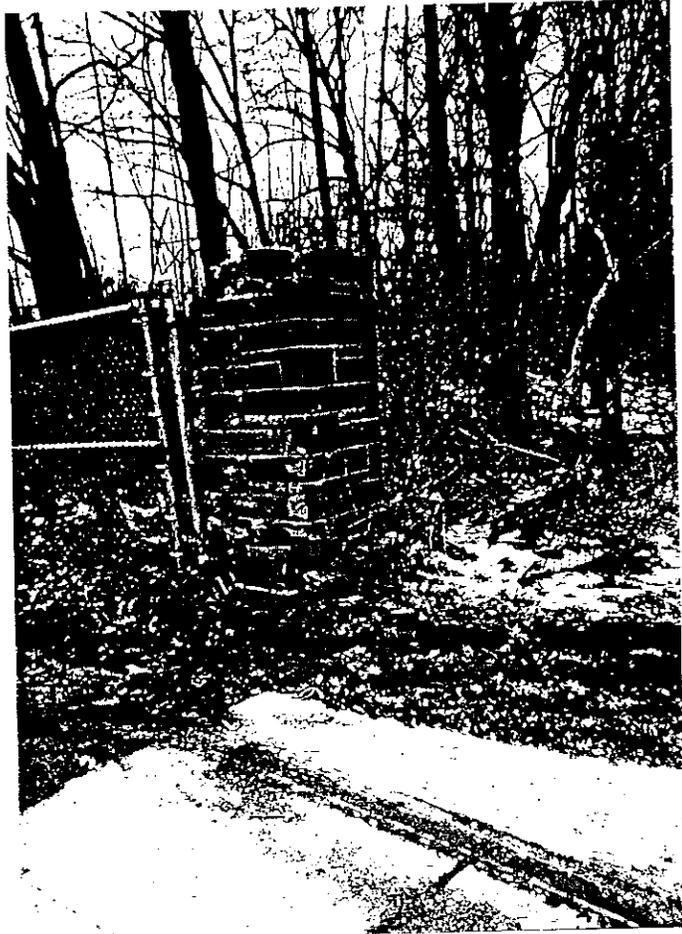
FIG. 41

MISSING STONE CAPS

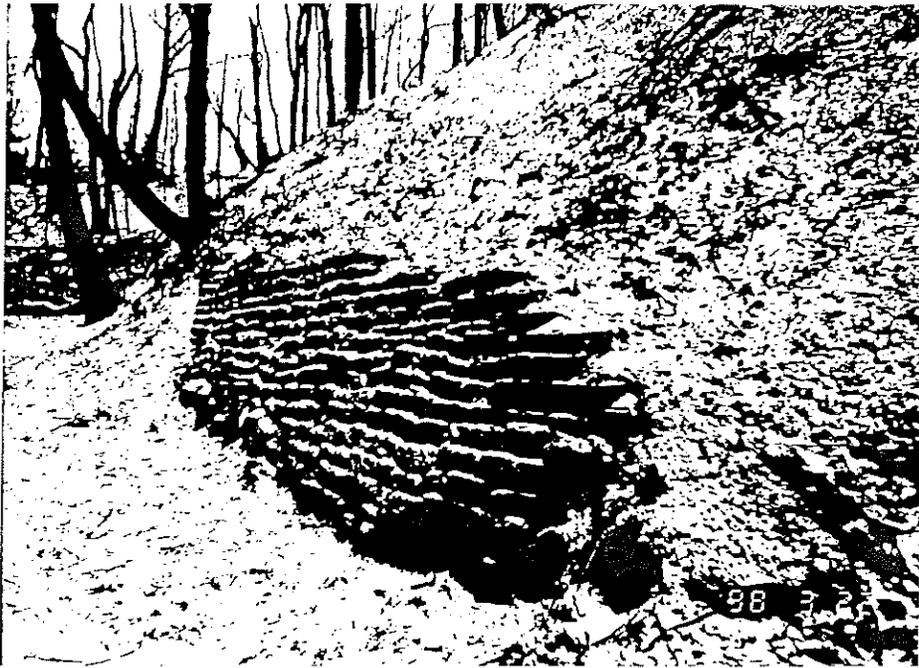
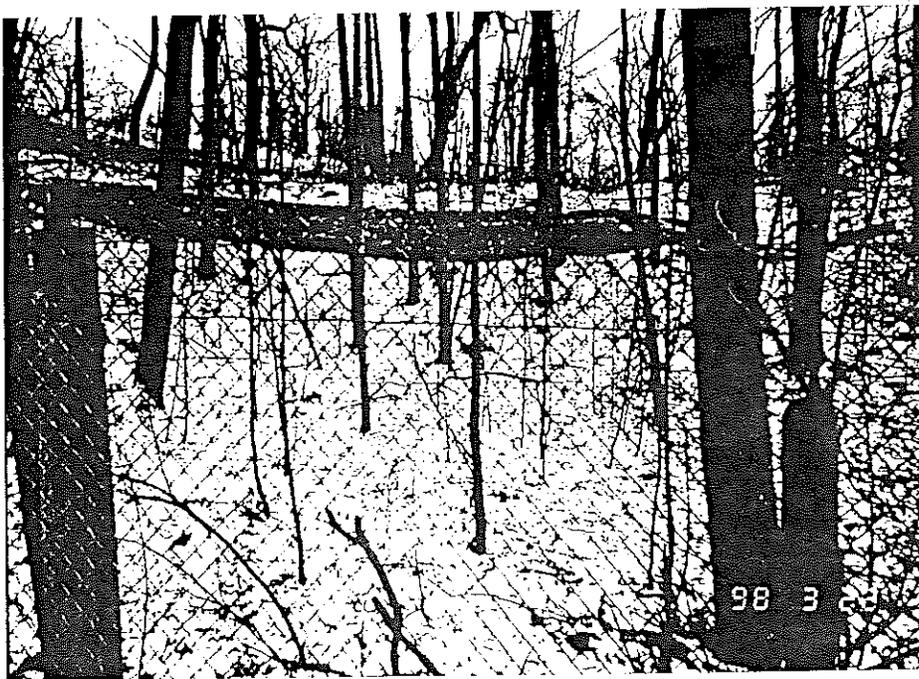
In the lower valley there are several terrace walls located at higher walking trail elevations that act as retaining walls to hold back earth slopes. It is speculated that these walls were placed early in the Park history. (See FIG.-45a, 45b, 45c, 45d, 45e) Drain pipes protrude through the masonry structures providing outlets for higher elevation storm water. If consideration is given to maintaining the associated earth slopes, reconstructing these walls and adding fill to retard any further erosion of embankment should be given strong consideration in the immediate future.
